Final
Cultural Landscape Report
Volume 1

Pahaquarry Copper Mine
DELAWARE WATER GAP

August 1995

by
Steve R. Burns Chavez
A. Berle Clemensen

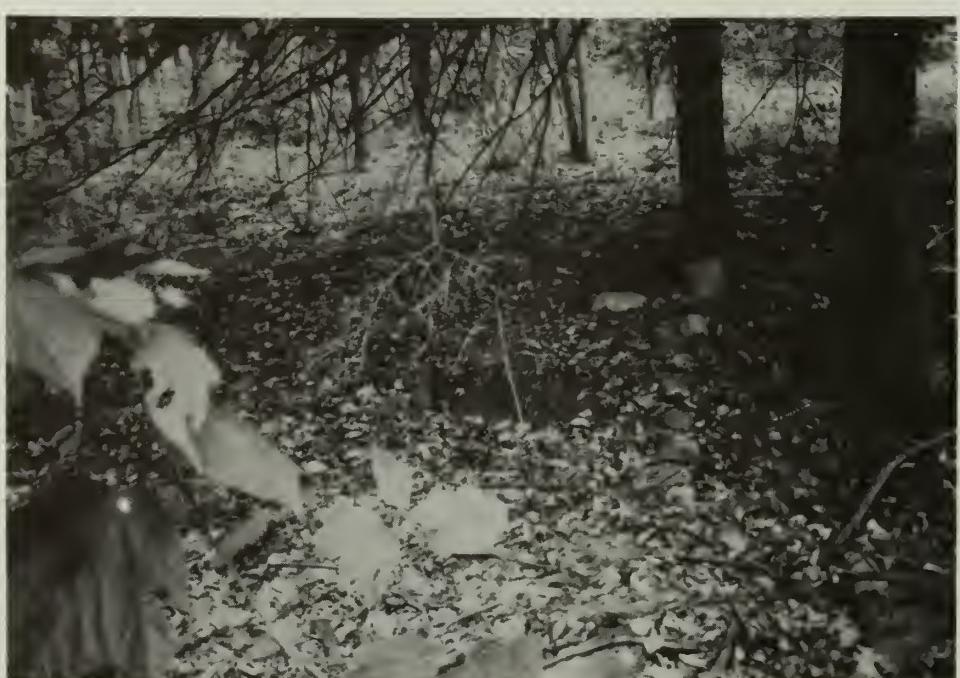
Figure 6E Photo 15
Boy Scout period ruins of rifle range

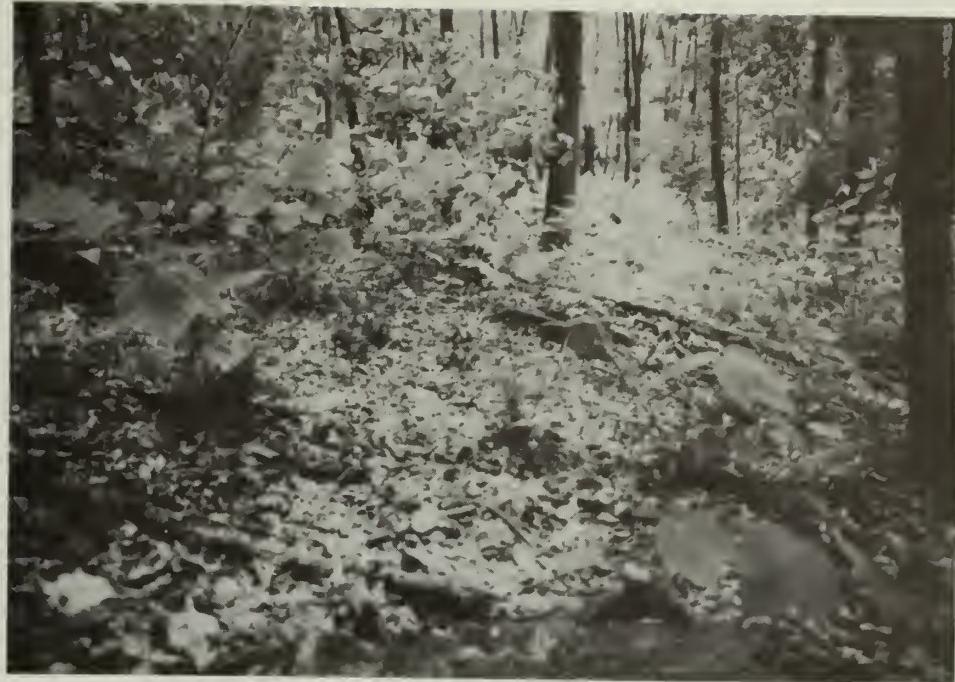
Figure 6E Photo 16
Boy Scout period ruins of amphitheater

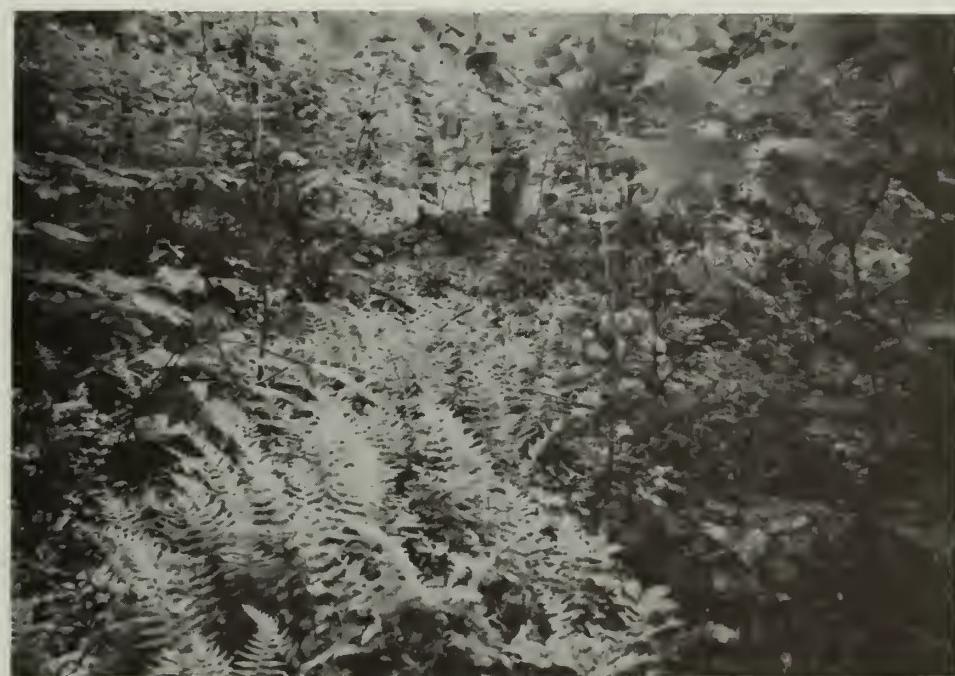
Figure 6E Photo 17
Boy Scout period remains of "unami" camp site

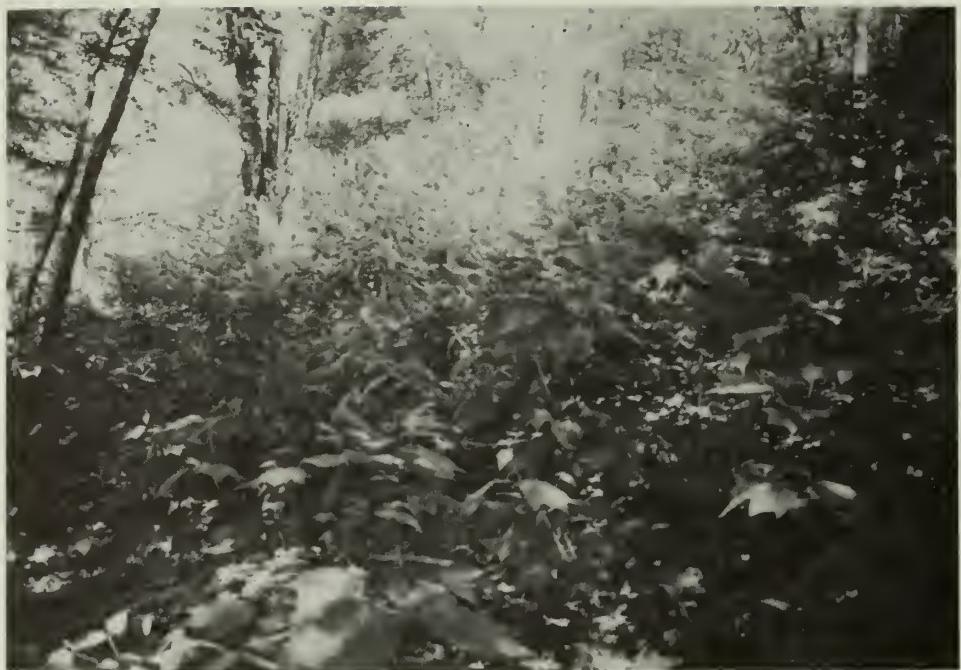
Figure 6E Photo 18
Boy Scout period remains of "unami" camp site

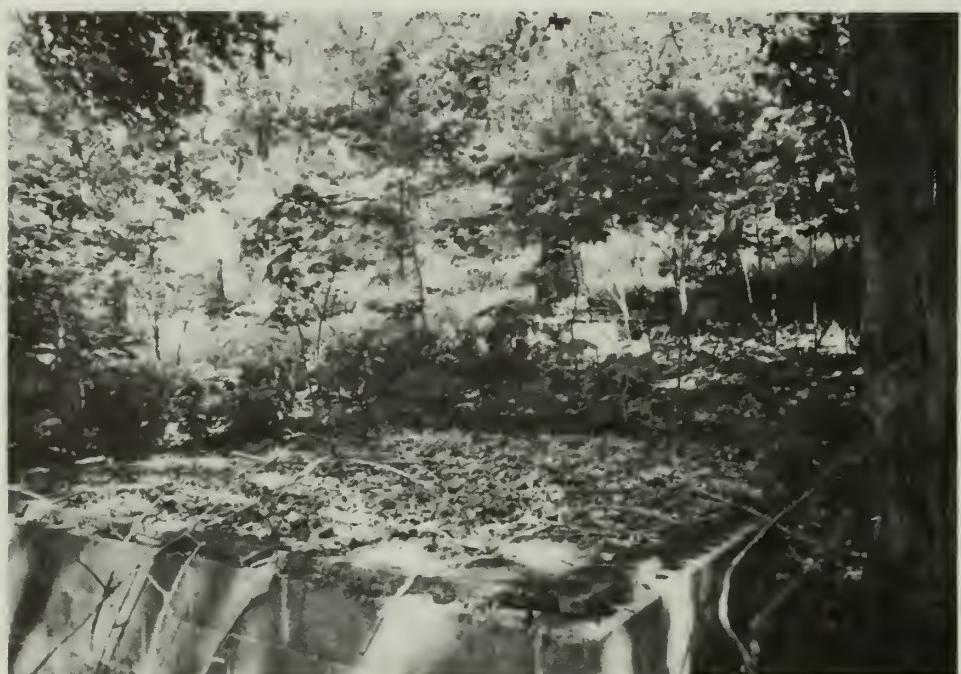
Figure 6E Photo 19
Boy Scout period remains of access road to camp sites at East end

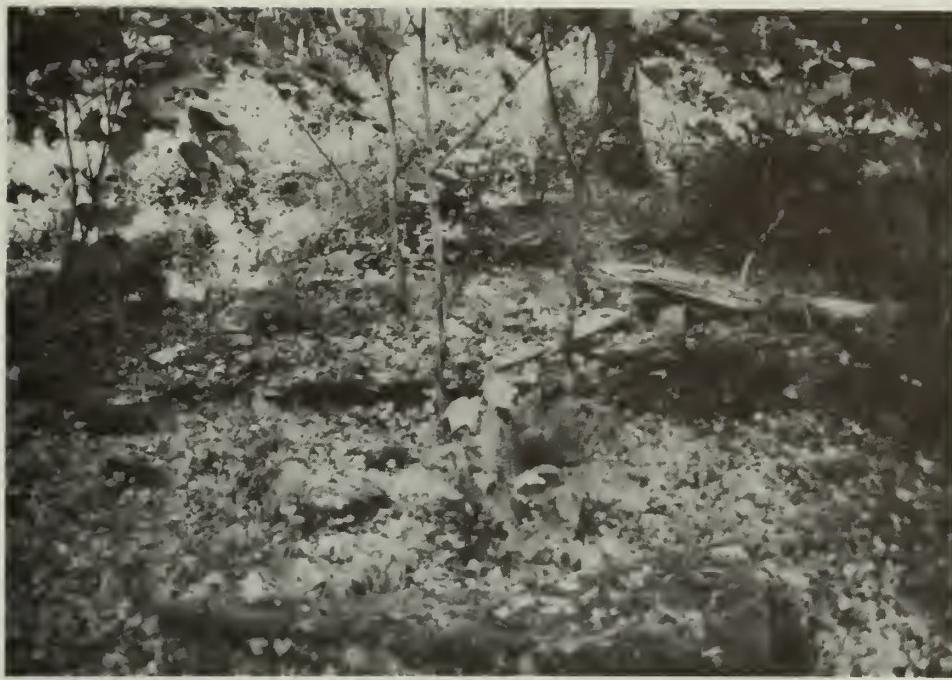
Figure 6E Photo 20
Boy Scout period remains of "Bischui" cabins

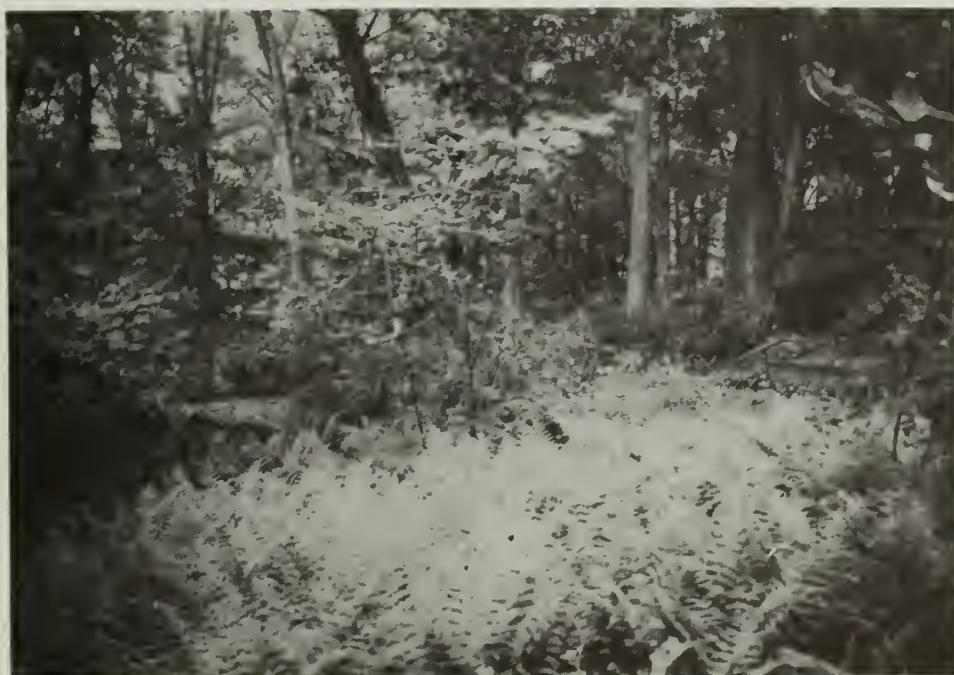
Figure 6E Photo 21
Boy Scout period remains of "Bischui" cabins

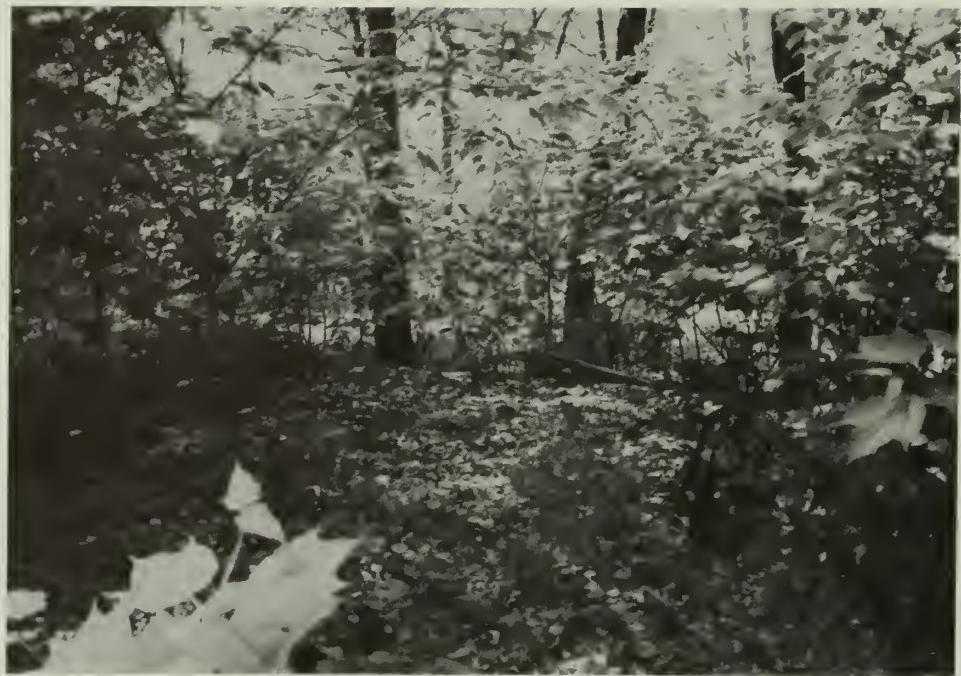
Figure 6E Photo 22
Boy Scout period remains of "Bischui" cabins

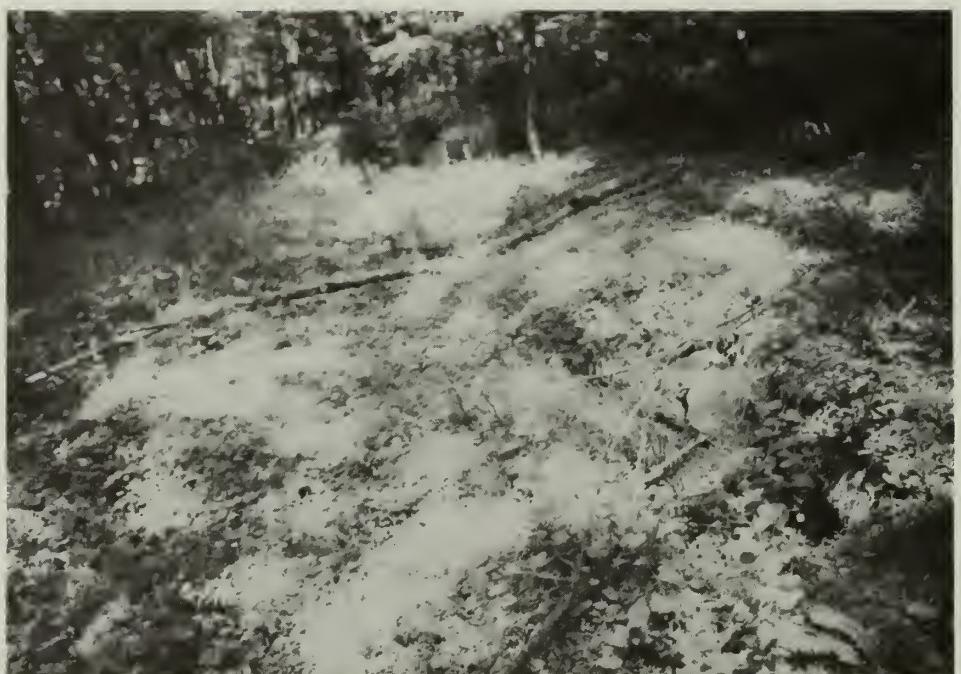
Figure 6E Photo 23
Boy Scout period remains of "Bischui" cabins

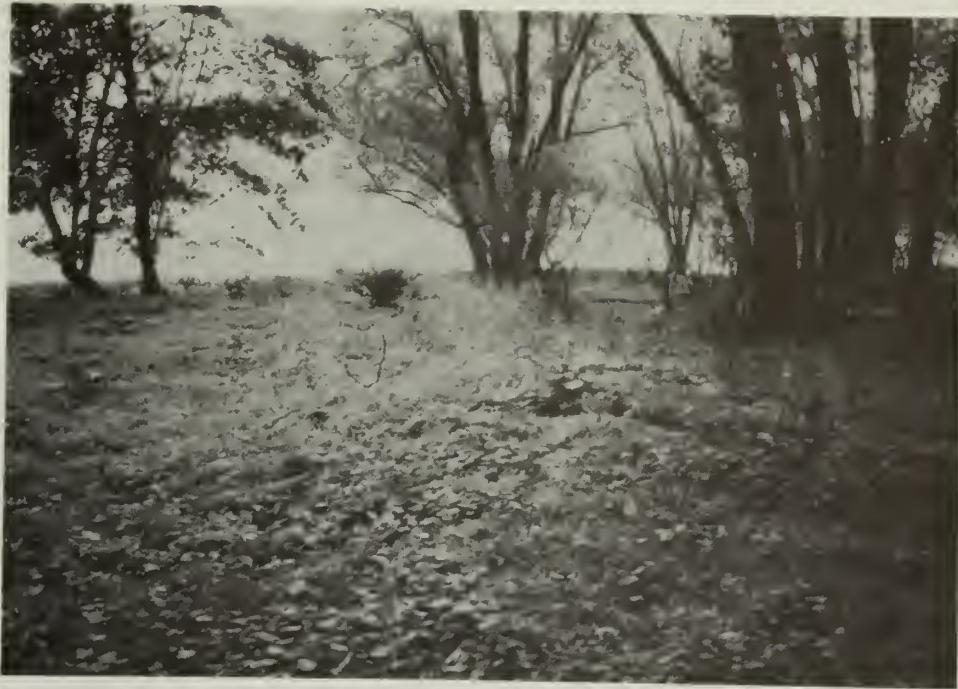
Figure 6E Photo 25
Boy Scout period remains of foundation for staff motel

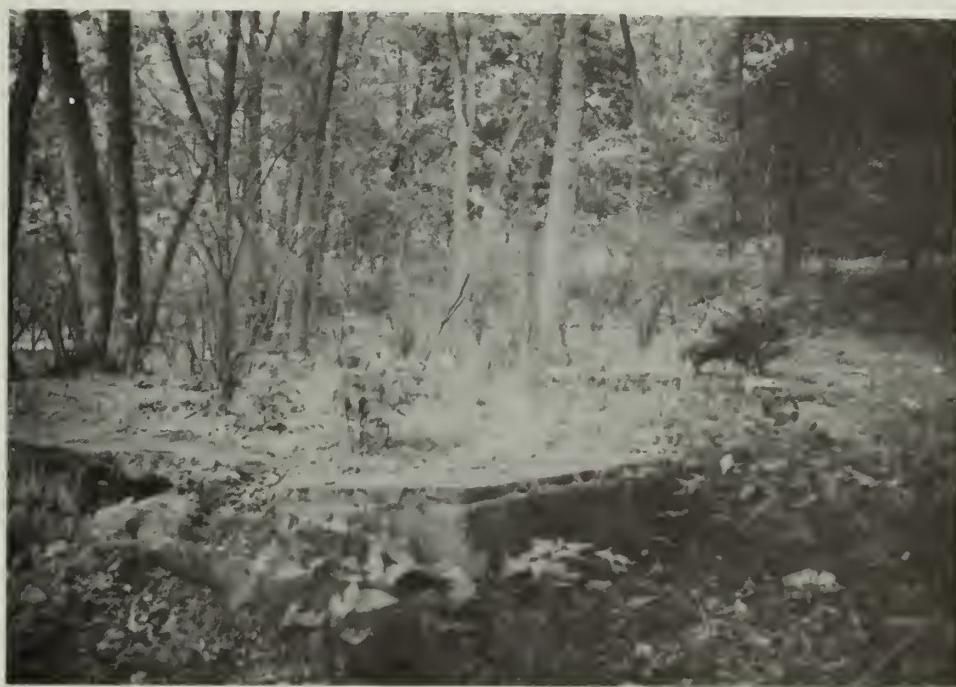
Figure 6E Photo 26
Boy Scout era remains of foundation for staff motel

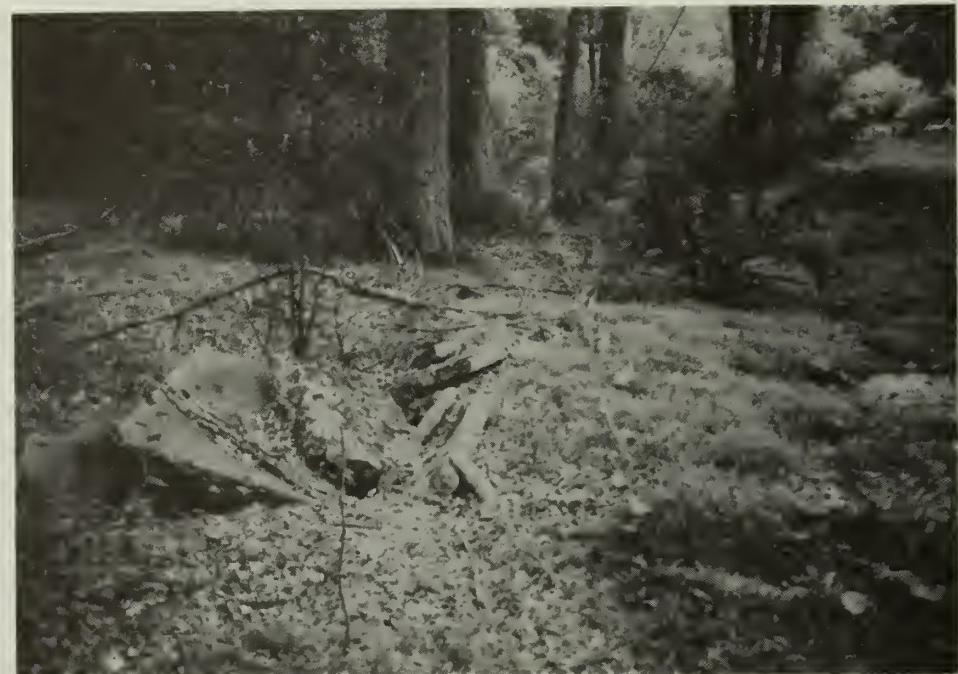
Figure 6E Photo 27
Boy Scout era remains of latrine

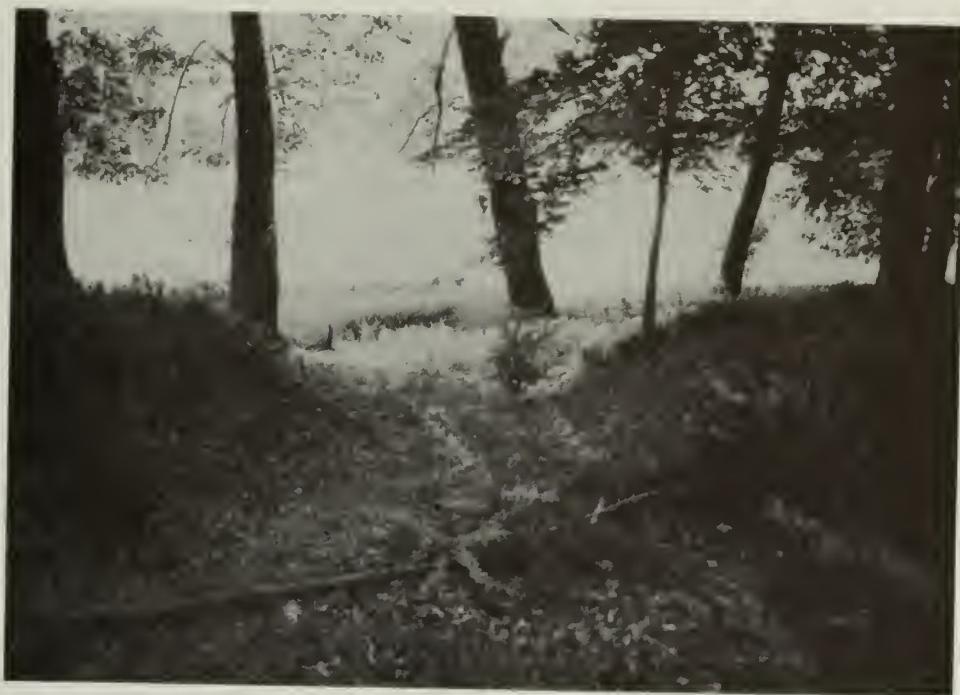
Figure 6E Photo 28
Boy Scout era remains of drinking fountain and clearing

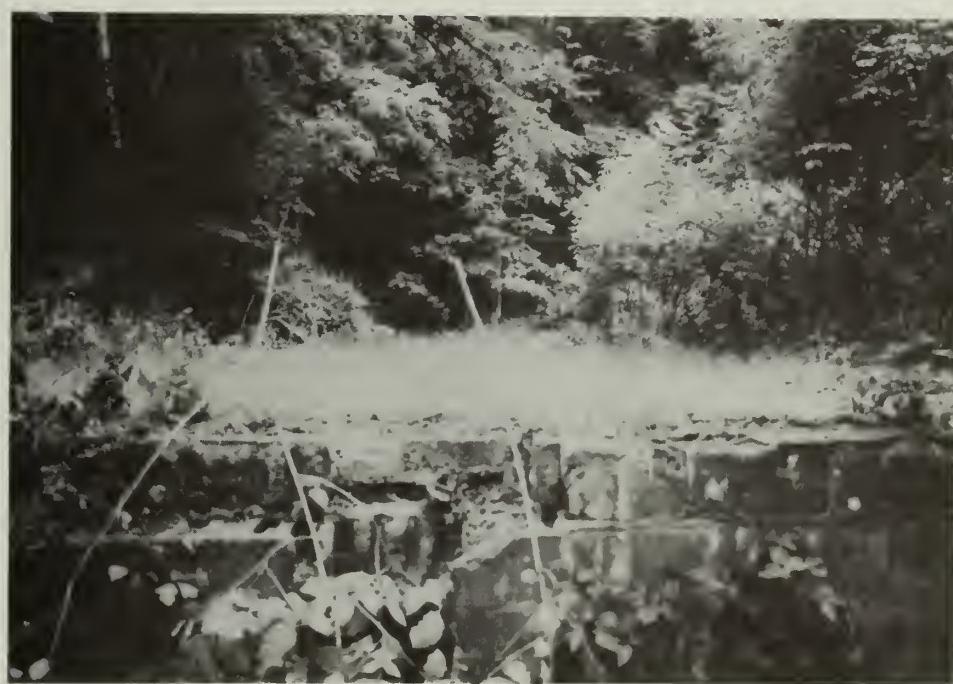
Figure 6E Photo 29
Boy Scout era remains of access to dock and river

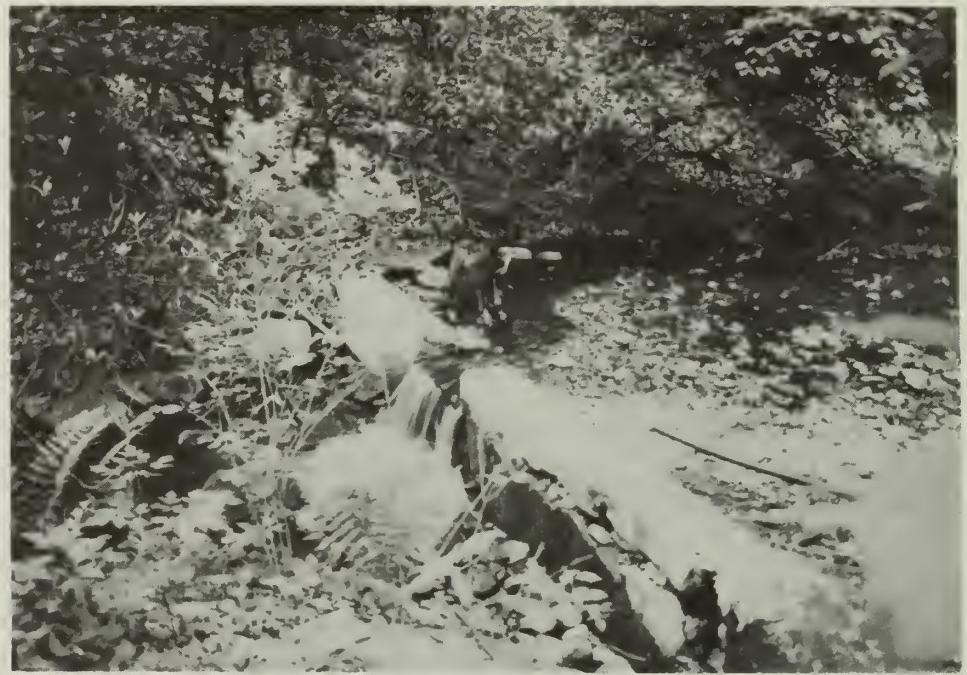
Figure 6E Photo 30
Boy Scout era remains of second mess hall added to mill

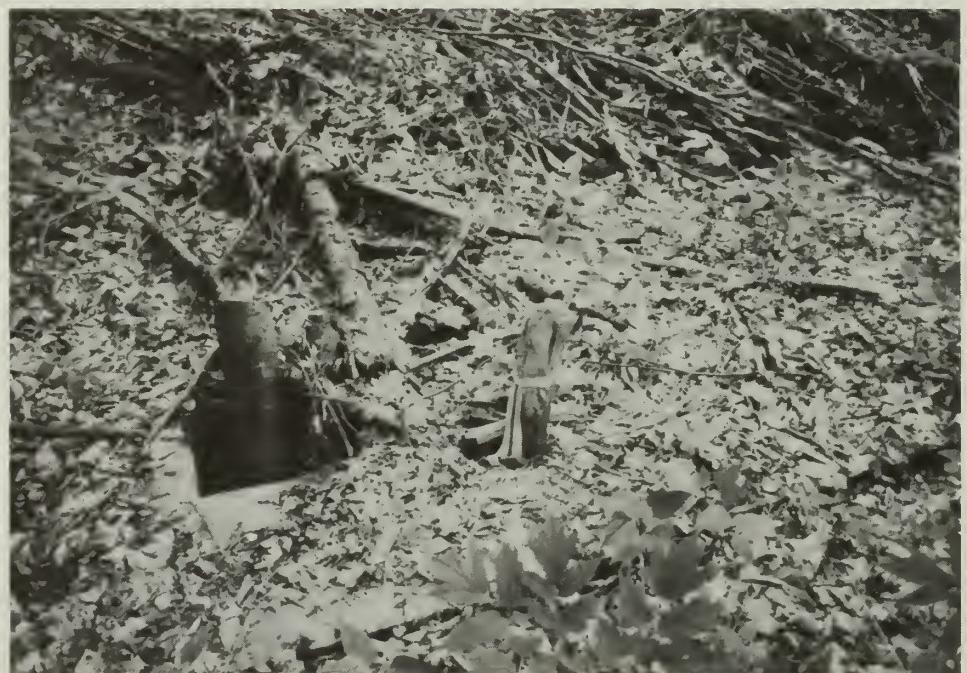
Figure 6E Photo 31
Boy Scout era dam on Minebrook

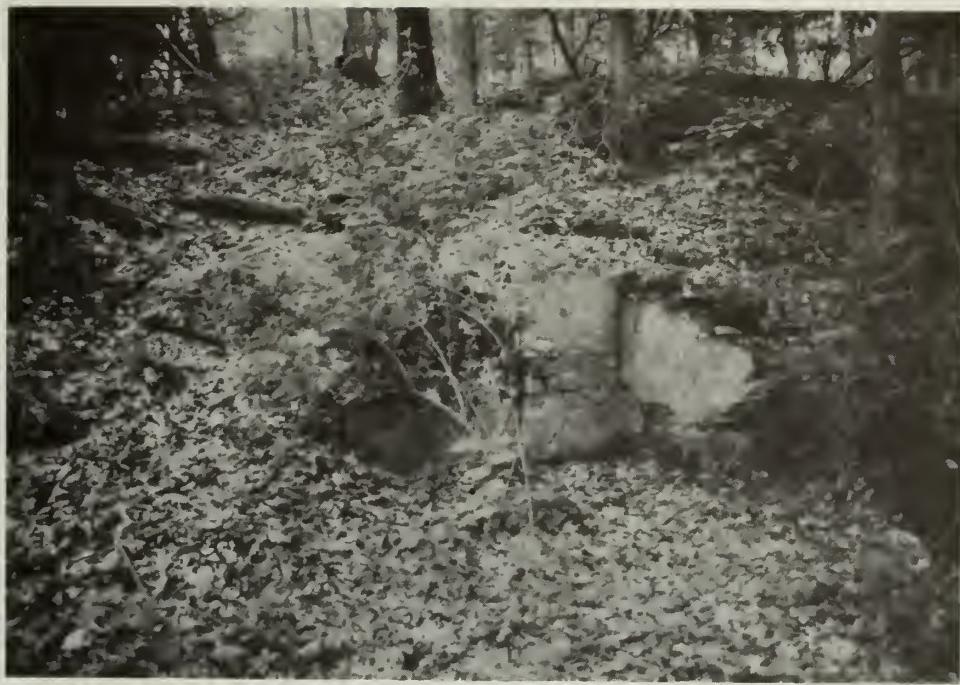
Figure 6E Photo 32
Boy Scout era remains of shower

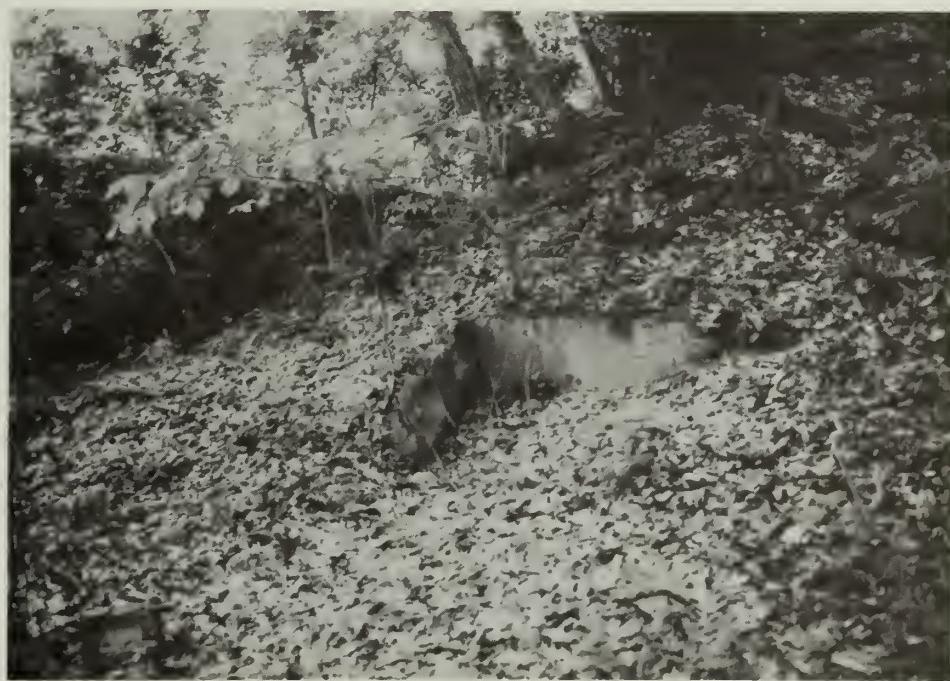
Figure 6E Photo 33
Supposed Boy Scout era remains of unknown structure

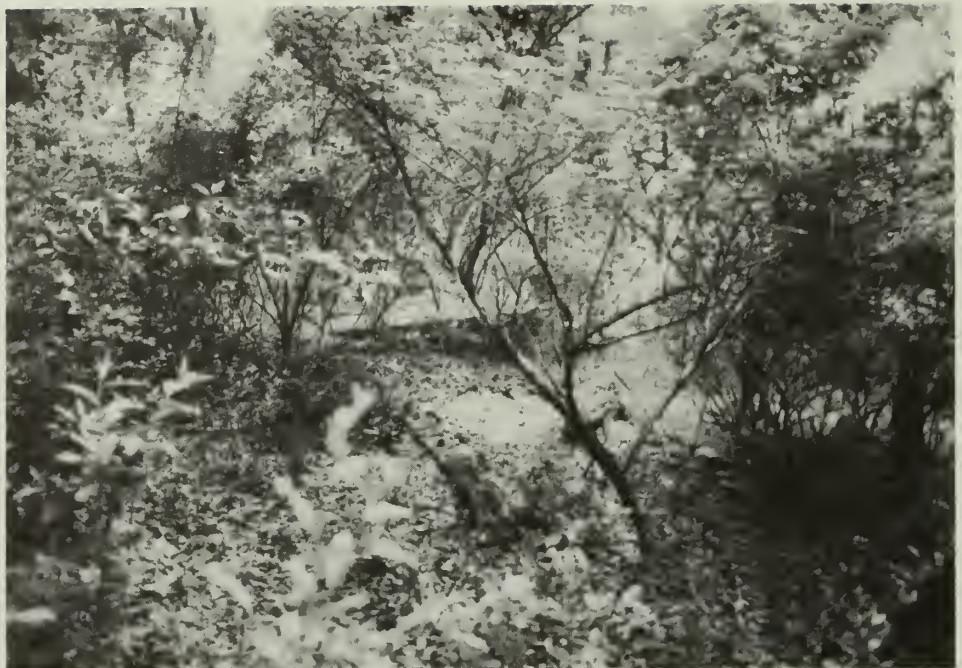
Figure 6E Photo 34
Supposed Boy Scout era remains of unknown structure

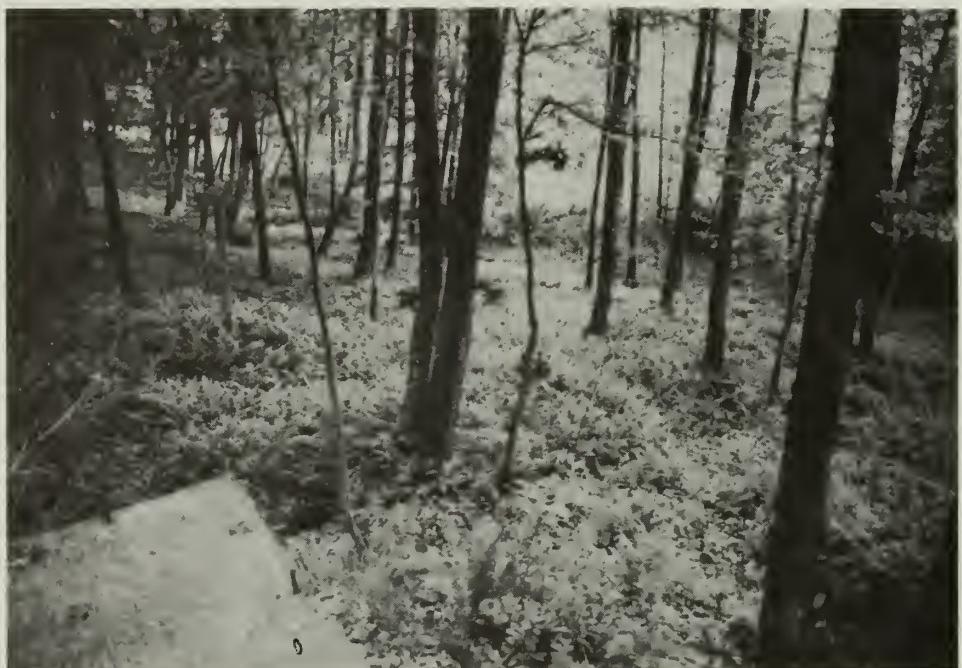
Figure 6E Photo 35
Boy Scout era remains of chapel

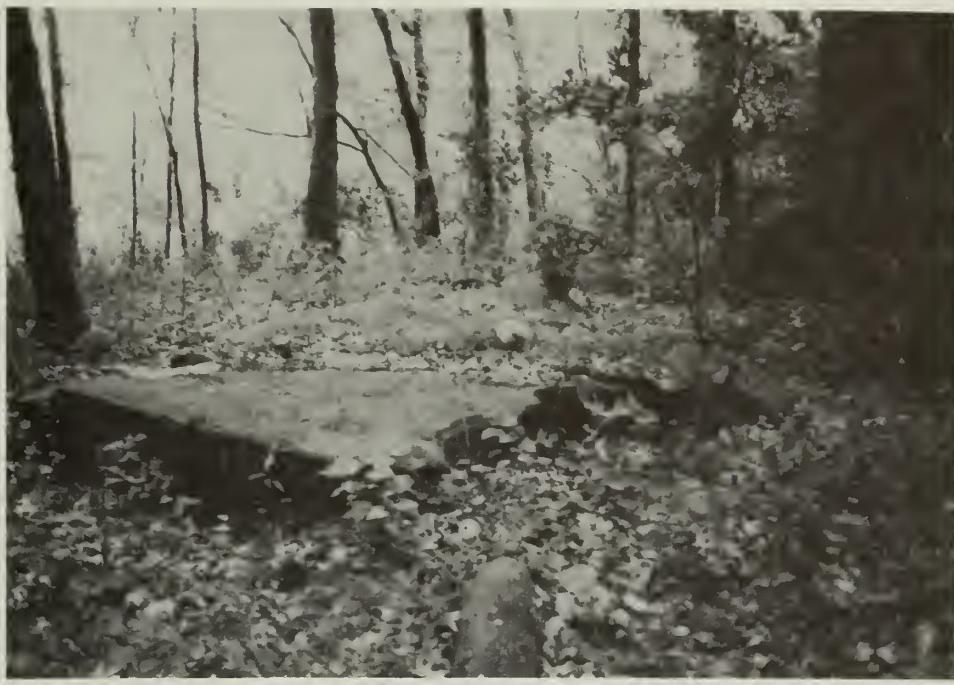
Figure 6E Photo 36
Boy Scout era remains of chapel and pillars along walk to chapel

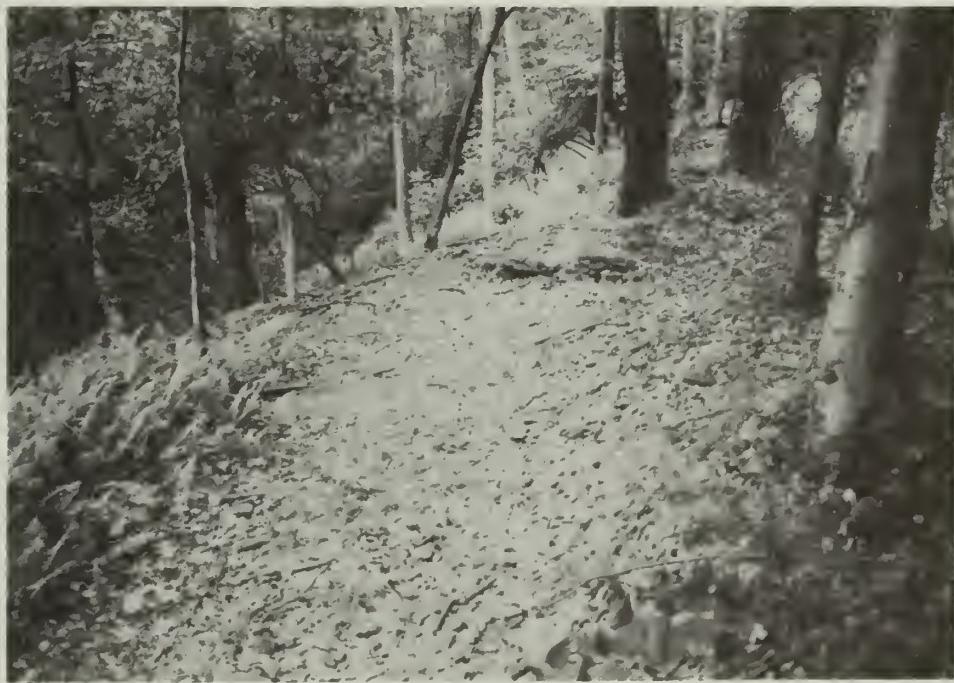
Figure 6E Photo 37
Boy Scout era remains of latrine and staff quarters
